FUNDAMENTAL INVESTIGATION OF FATIGUE CRACK GROWTH RETARDATION IN ALUMINUM ALLOYS

Northrop Corporation
Aircraft Division
3901 West Broadway
Hawthorne, California 90250

SEPTEMBER 1976

TECHNICAL REPORT AFML-TR-76-156

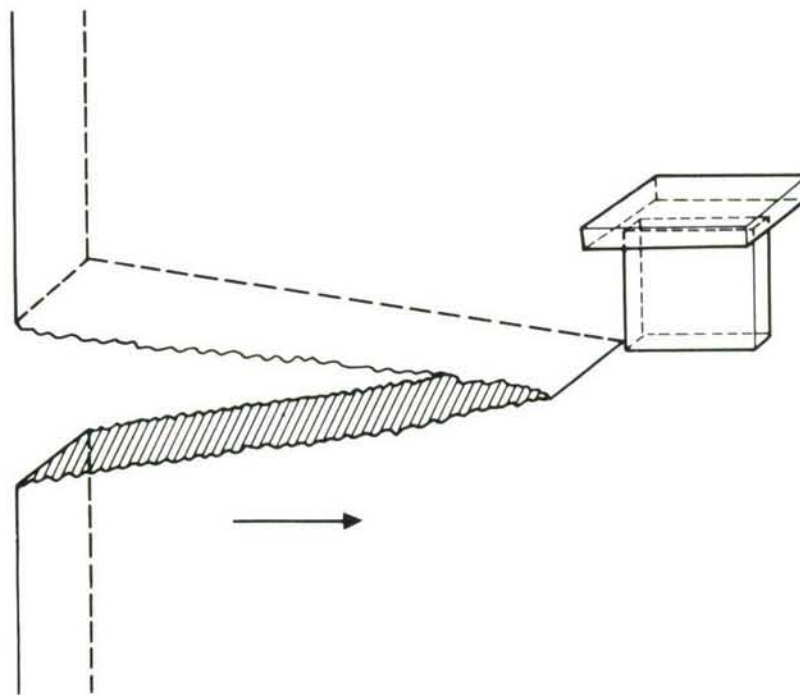
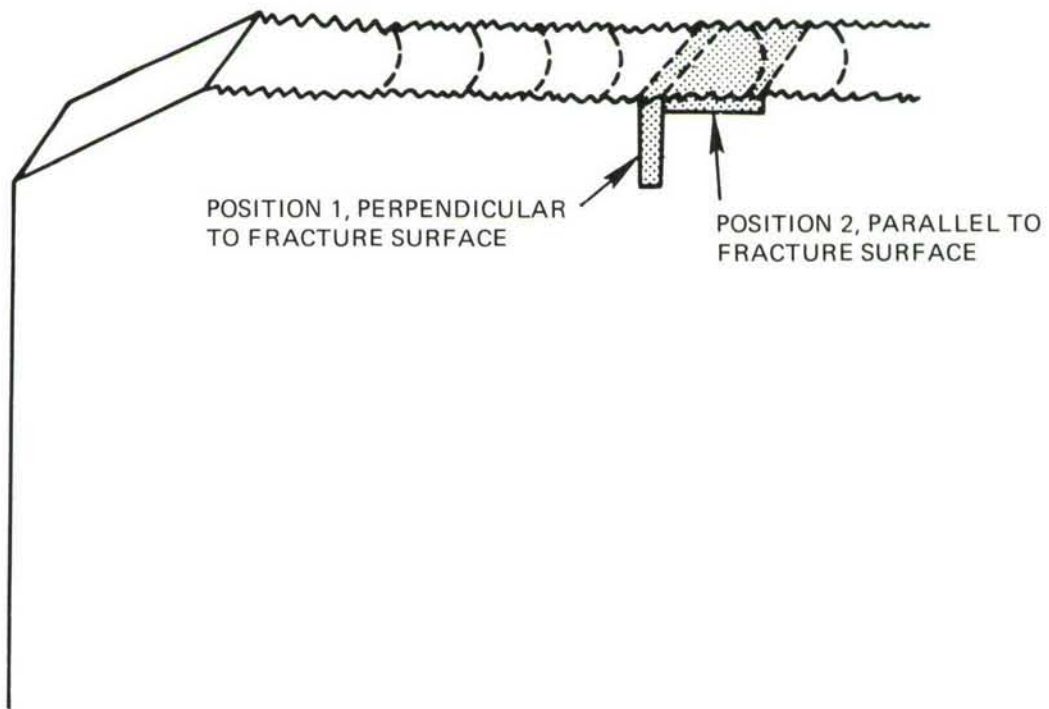
(a) FOR CHARACTERIZATION OF PLASTIC ZONE

(b) FOR FAILED FCP AND RETARDATION SPECIMENS

FIGURE 4. POSITIONS FOR THIN FOIL REMOVAL FROM TEST SPECIMENS

Examination of foils from position 2 in Figure 4 (b) showed more substructural interactions in the T8 condition as a result of FCP than in the T3 condition. Evidence of an increased density of S' precipitates was seen. The fine acicular structure was

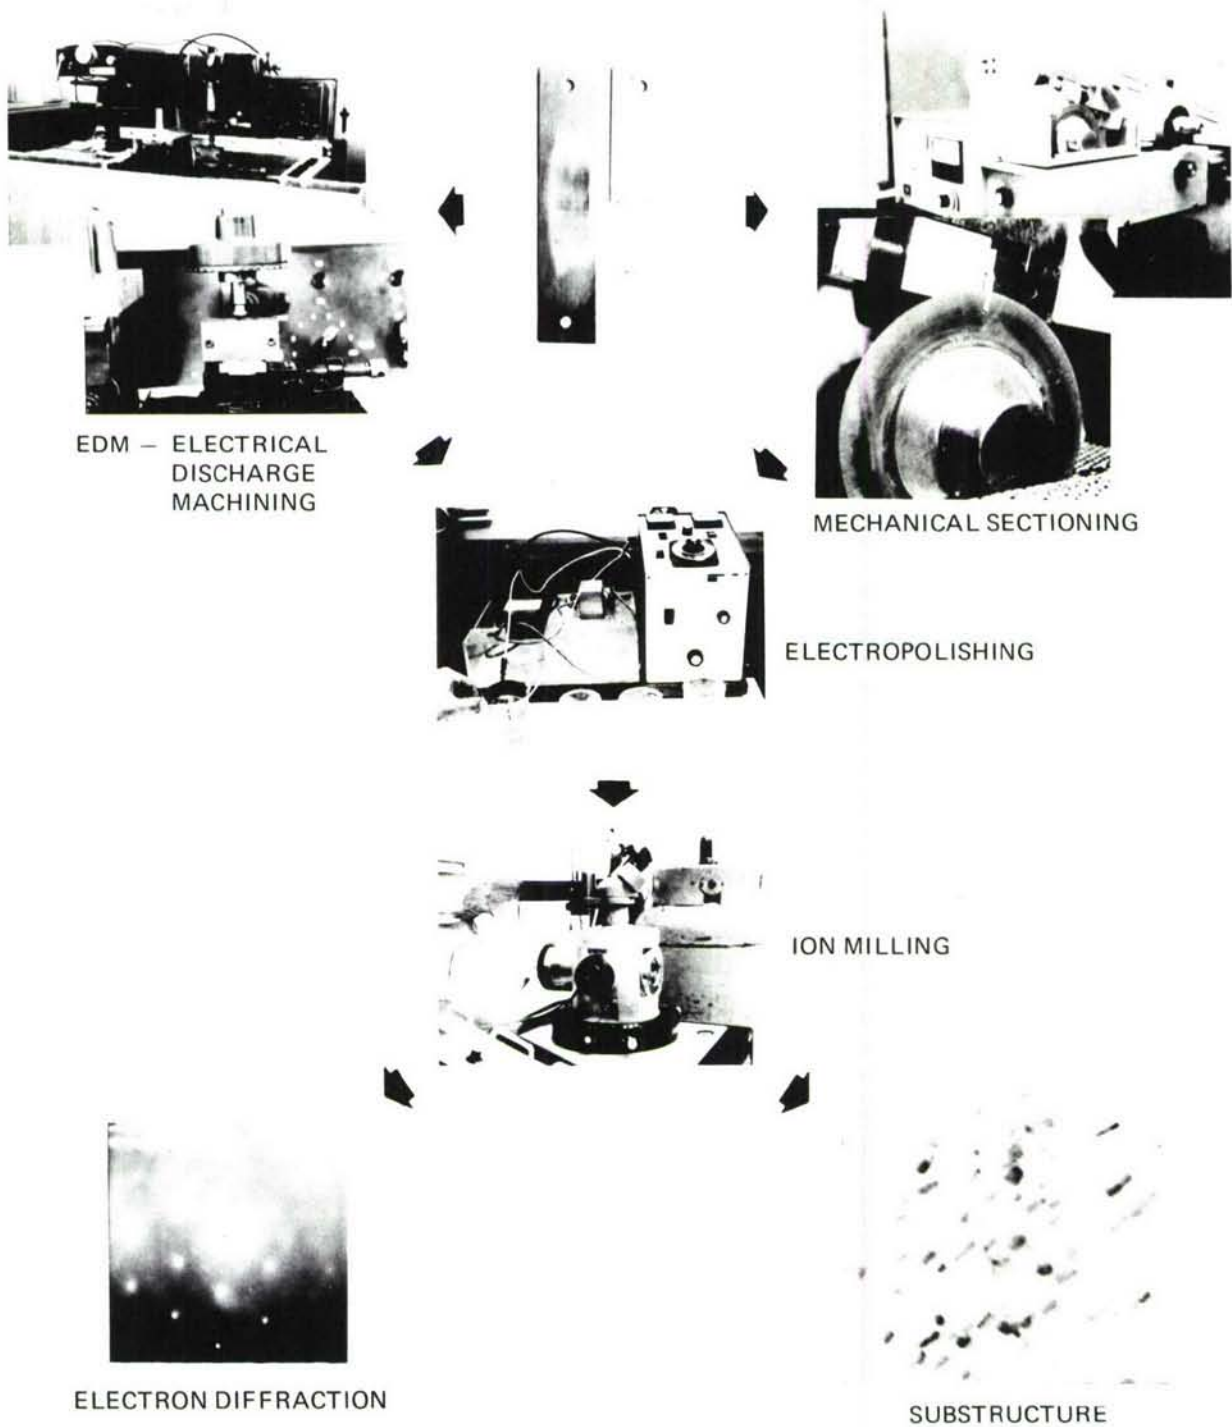
FIGURE 5. PREPARATION PROCEDURE FOR TEM FOILS

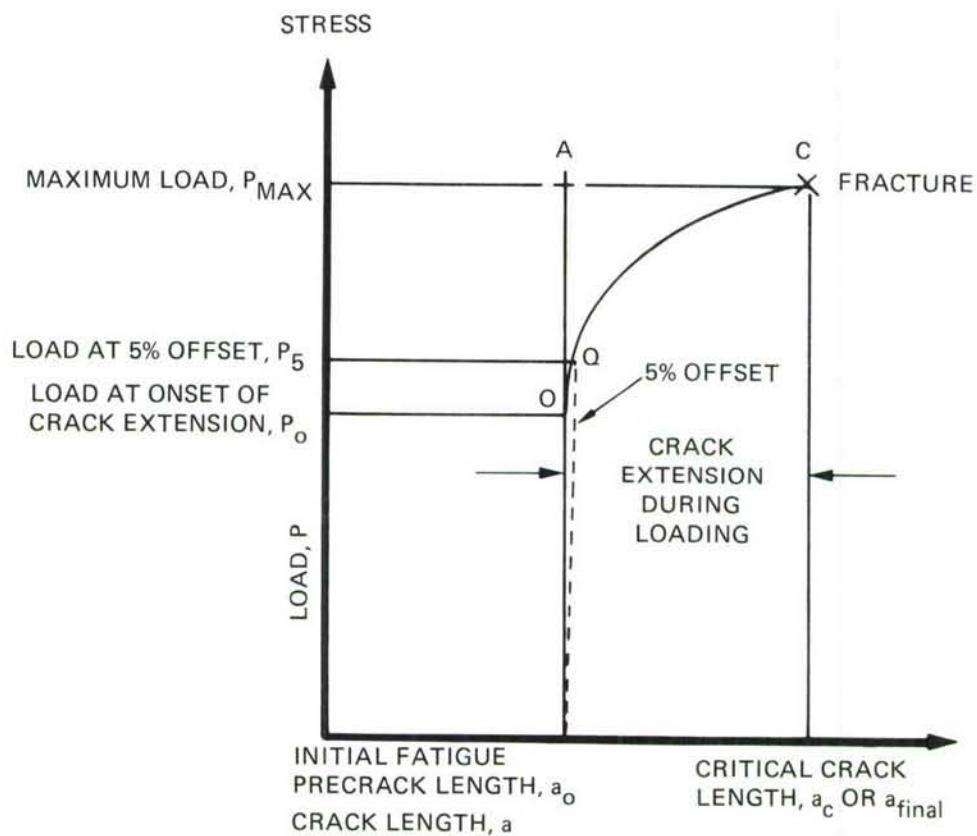
FIGURE 7. SCHEMATIC OF CRACK-GROWTH BEHAVIOR IN PLANE STRESS CONDITION

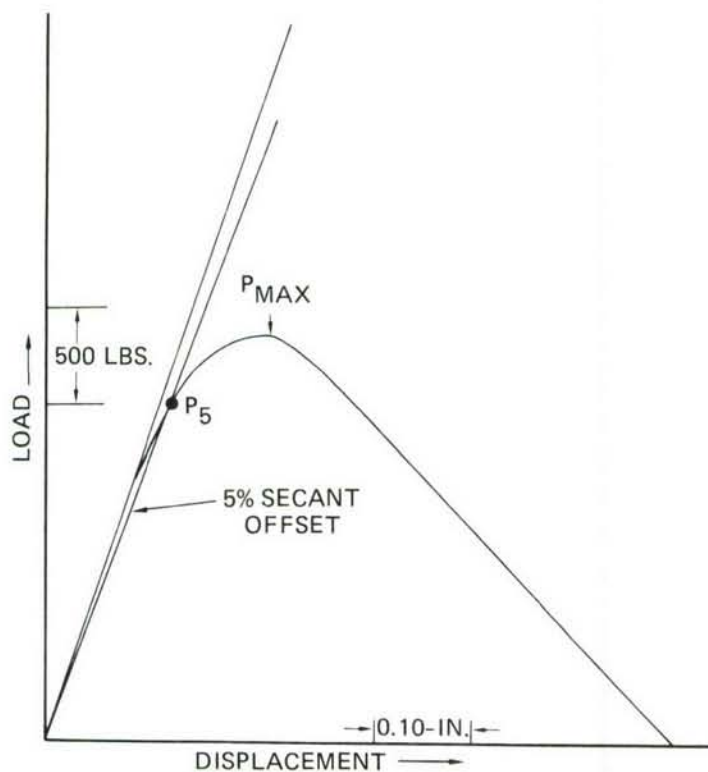
FIGURE 8. LOAD-DISPLACEMENT RECORD USING CLIP-ON GAGE FOR A 0.063-IN. SEN SPECIMEN OF 2024-T8 ALLOY

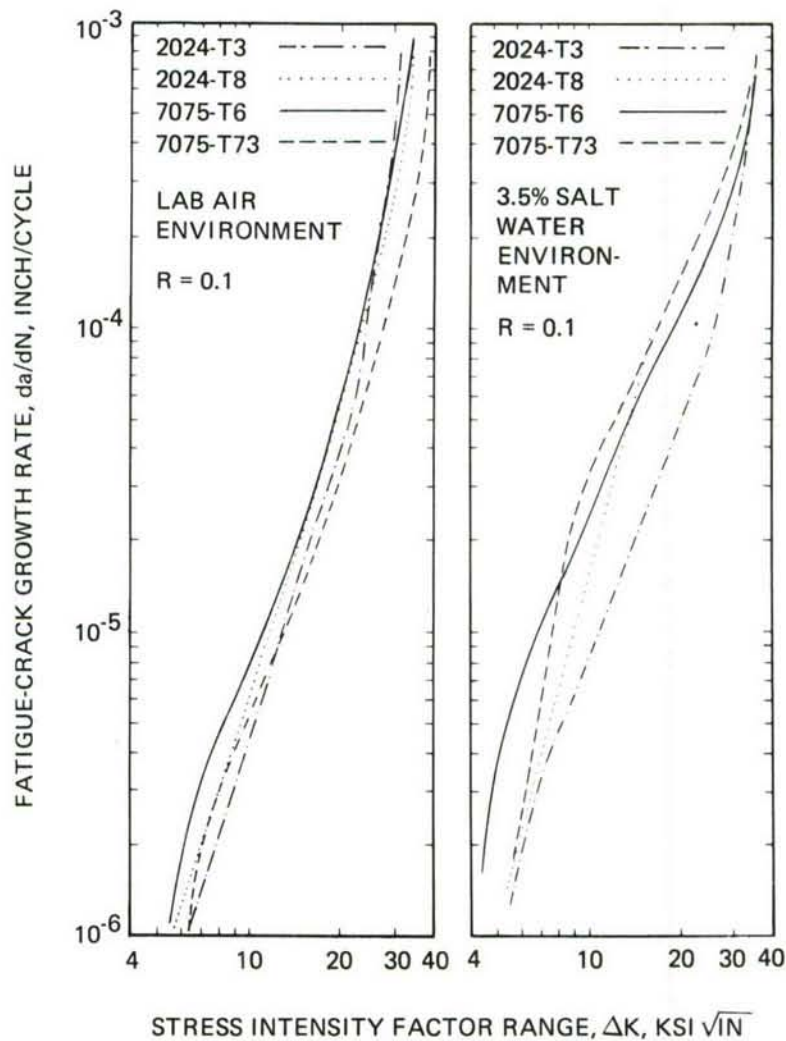
FIGURE 10. GENERAL TREND OF FCP BEHAVIOR FOR ALL FOUR CONDITIONS

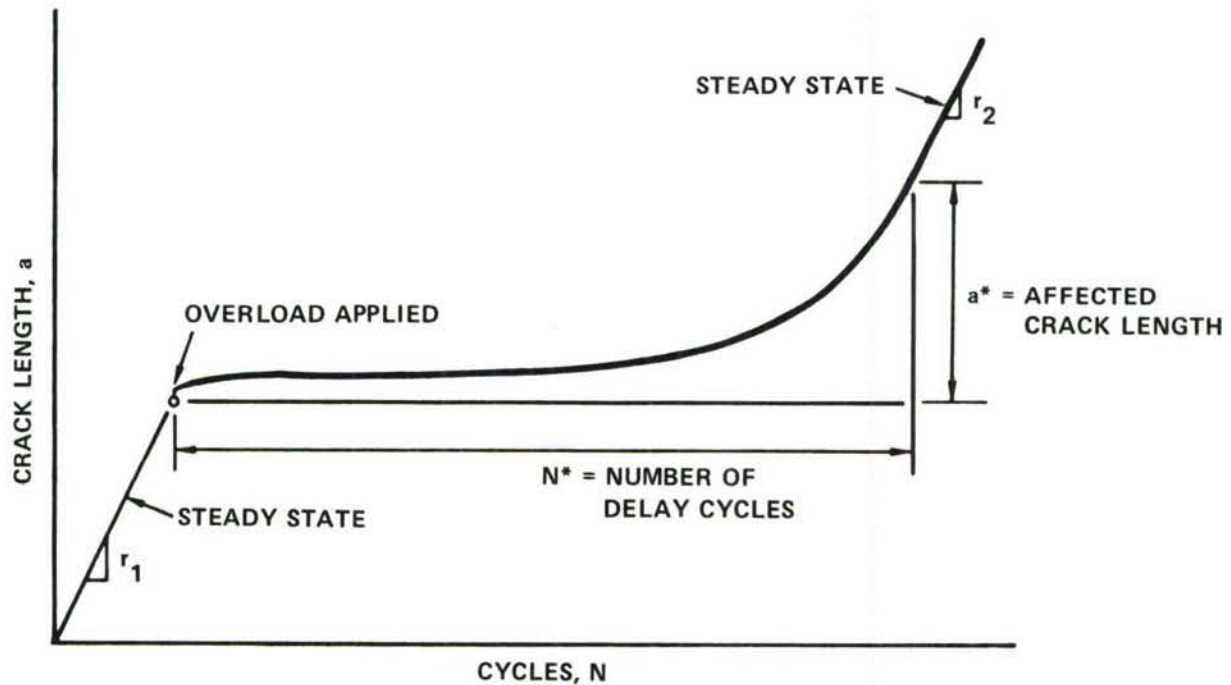
FIGURE 21. CRACK-GROWTH RATE CURVE RESULTING FROM APPLICATION OF A SINGLE OVERLOAD

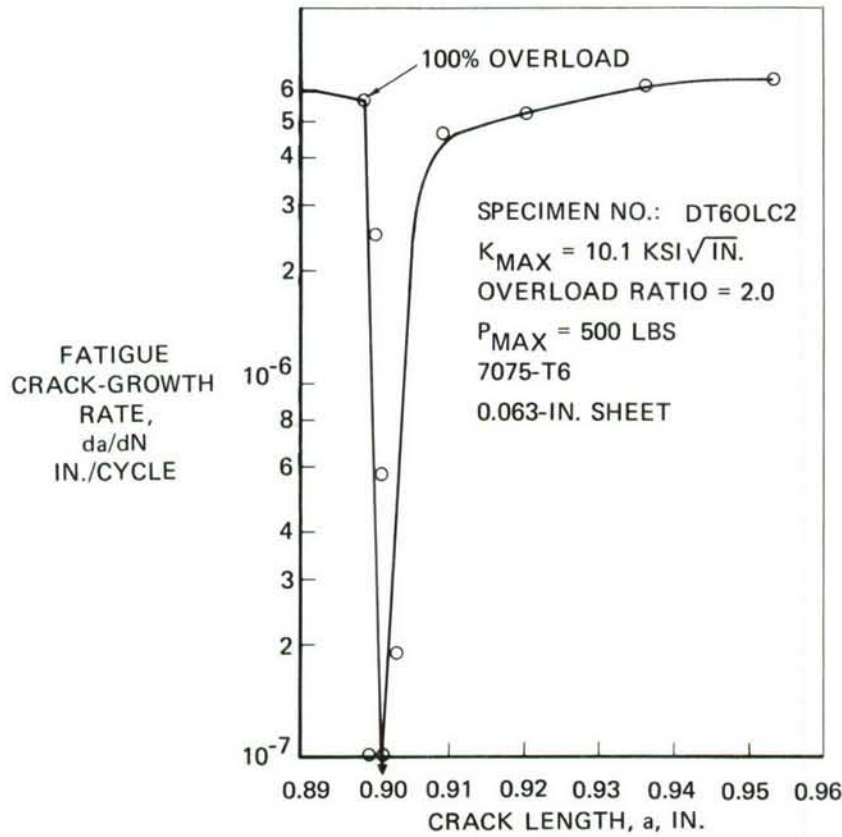
FIGURE 23. INFLUENCE OF 100% OVERLOAD ON SUBSEQUENT CRACK-GROWTH RATES IN AIR FOR 7075-T6

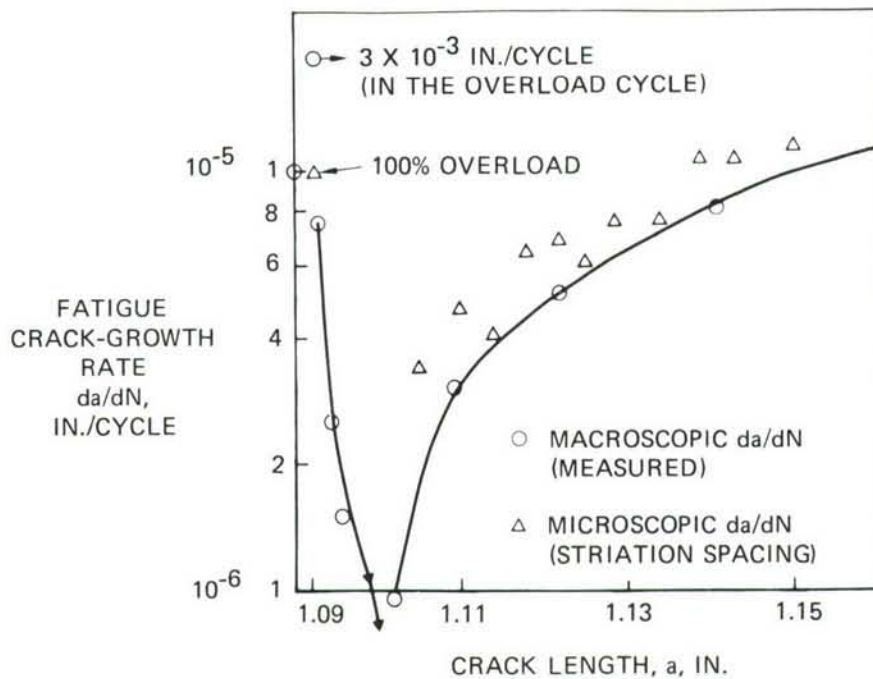
FIGURE 30. INFLUENCE OF 100% OVERLOAD ON SUBSEQUENT CRACK-GROWTH RATES IN AIR FOR 7075-T6 ALLOY

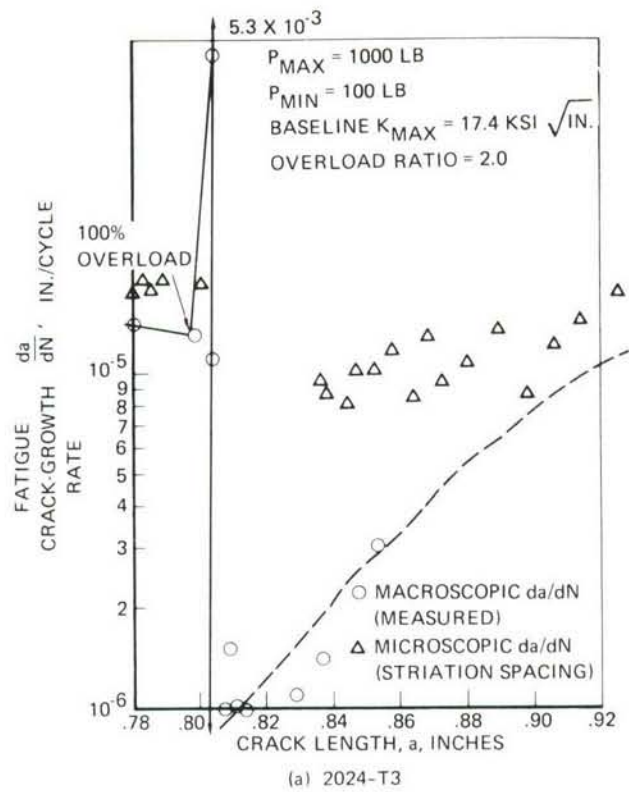
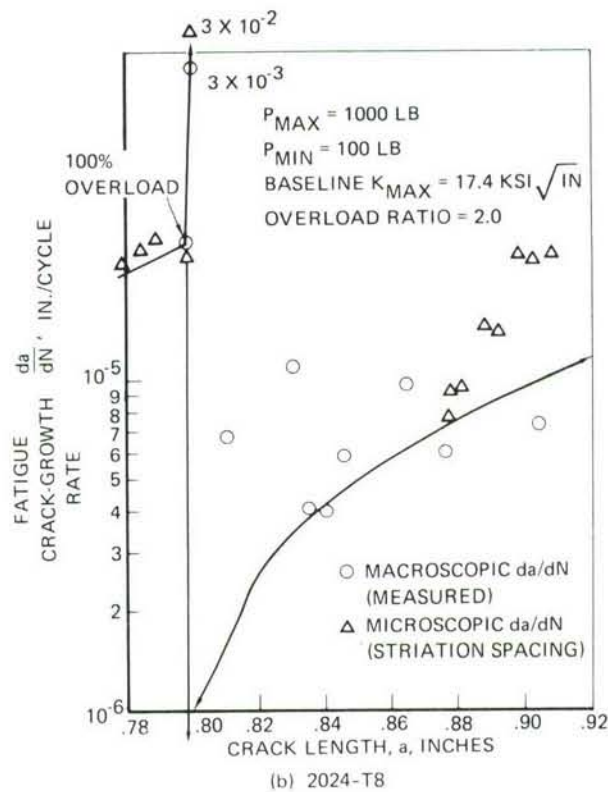
FIGURE 36. THE INFLUENCE OF 100% OVERLOAD CYCLE ON SUBSEQUENT CRACK-GROWTH RATES IN AIR FOR 2024 ALLOY

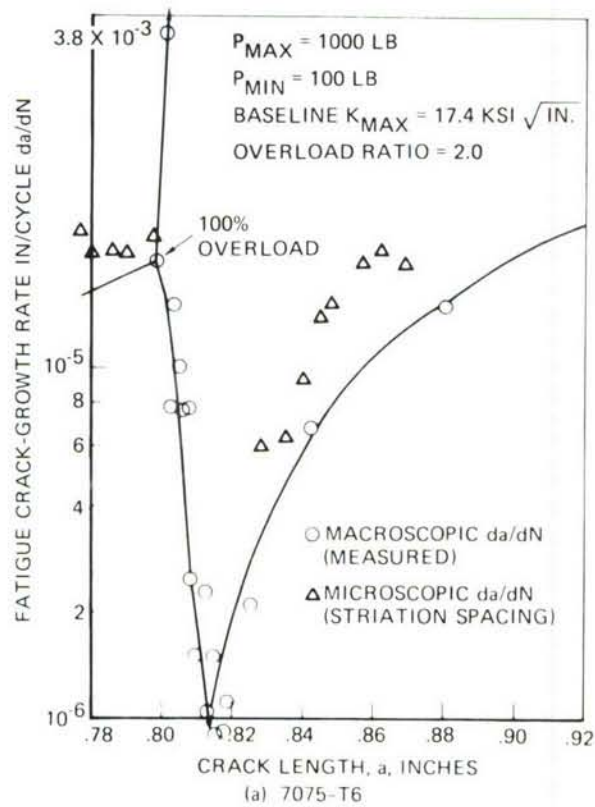
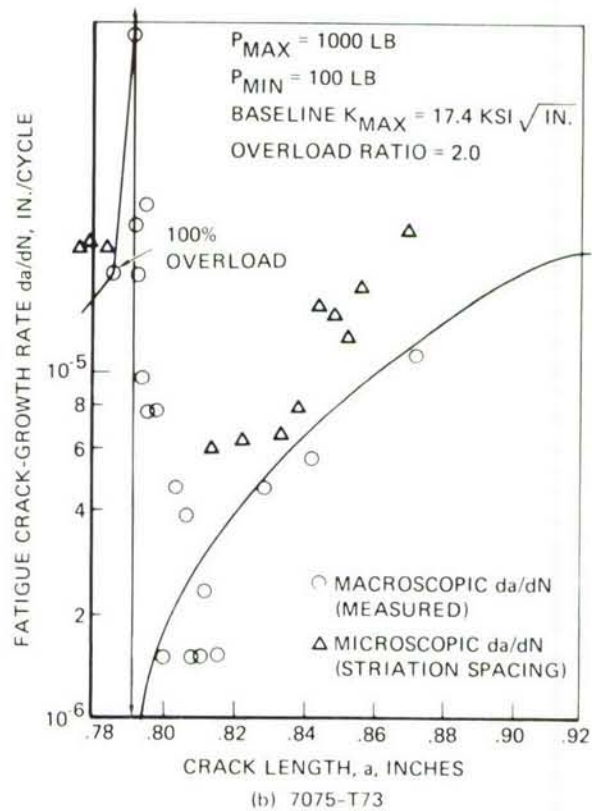
FIGURE 37. THE INFLUENCE OF 100% OVERLOAD CYCLE ON SUBSEQUENT CRACK-GROWTH RATES IN AIR FOR 7075 ALLOY

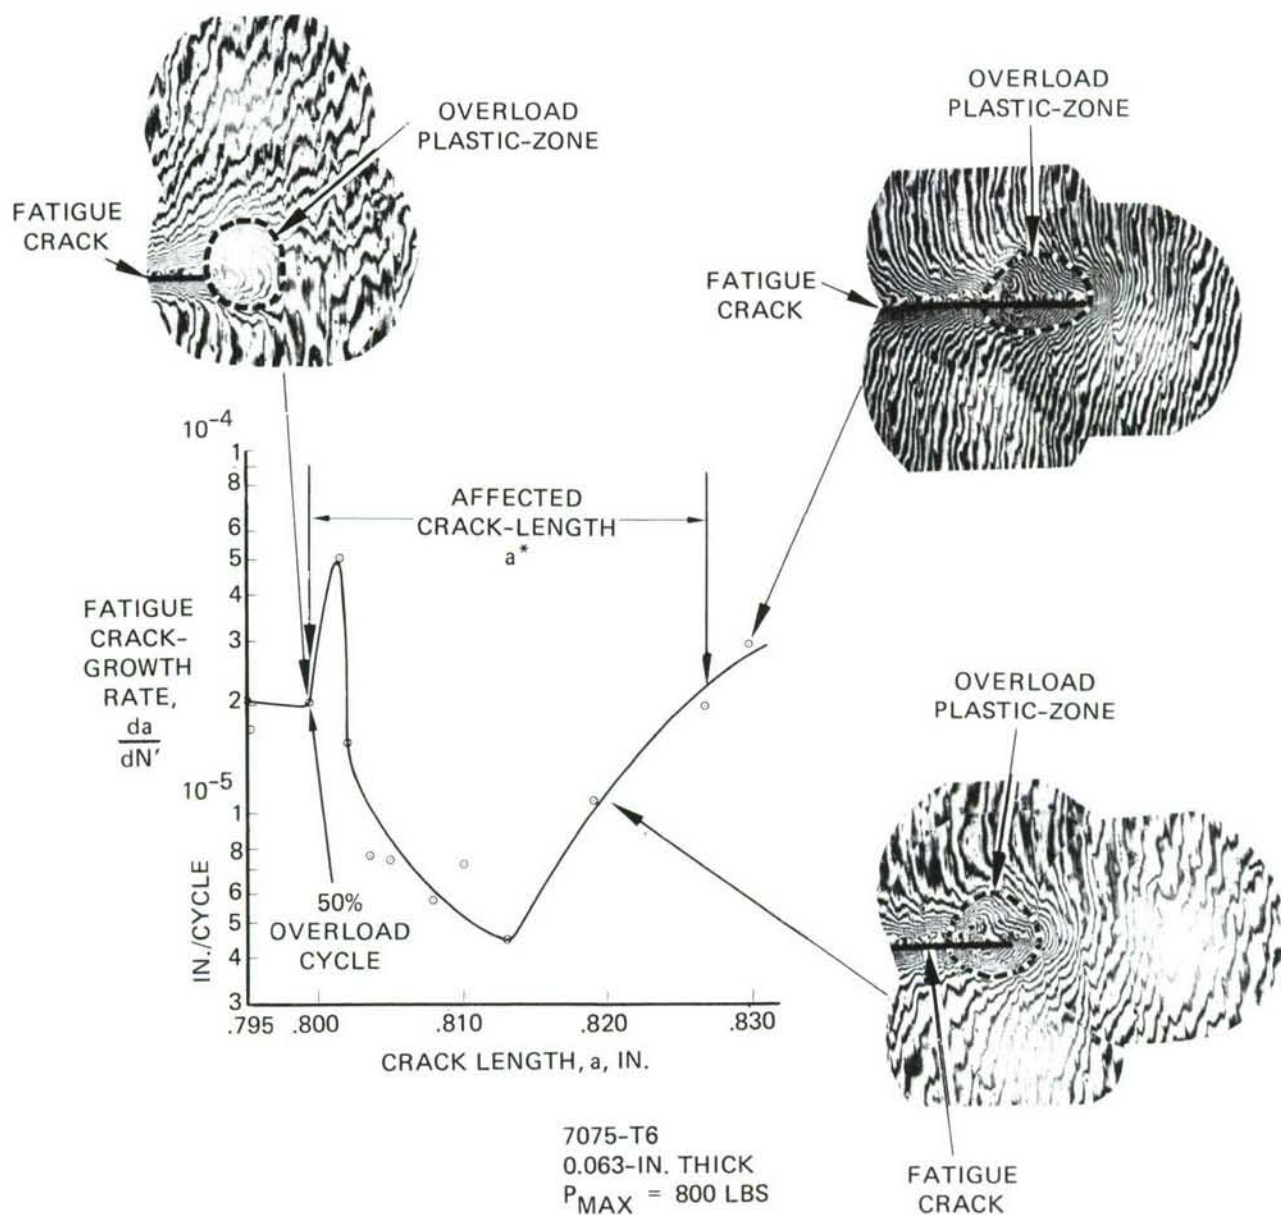
FIGURE 40. INTERFERENCE PATTERNS AT DIFFERENT STAGES OF CRACK-GROWTH AFTER A 50% OVERLOAD CYCLE

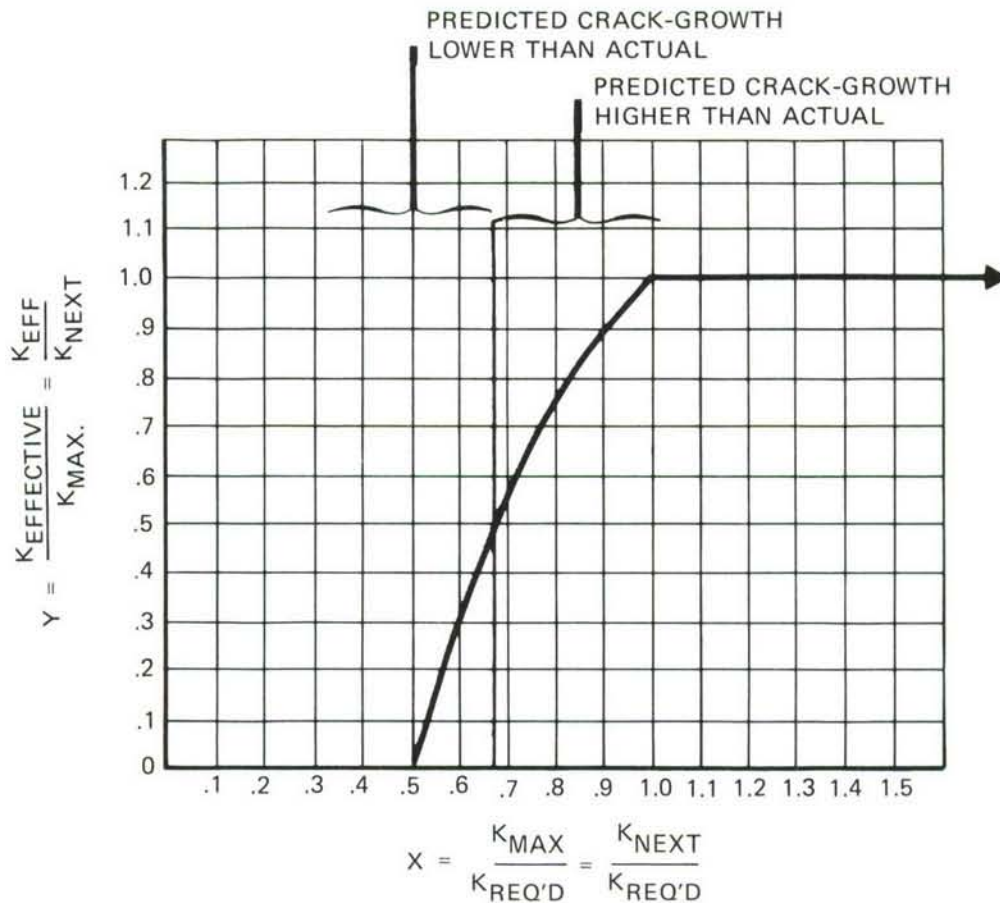
FIGURE 43. WILLENBORG RETARDATION CURVE

Test results in this program (Tables V and VI) and elsewhere ⁽²⁵⁾ show that crack-growth is not arrested for 50% loads (OLR = 2.0) and, depending on the specimen, the load level, and the alloy, perhaps not even arrested for 40% loads (OLR = 2.5). For 2024-T8 alloy, an overload ratio of 3.0 (33-1/3% of load) at a relatively high K was required to fully arrest the crack-growth. Comparison of the test results with the Willenborg model also showed that the Willenborg model predicts crack-growth lower than the actual crack-growth for loads up to 60% to 70%, and higher crack-growth for loads from 70% to 100%, of the overload as shown schematically in Figure 43.

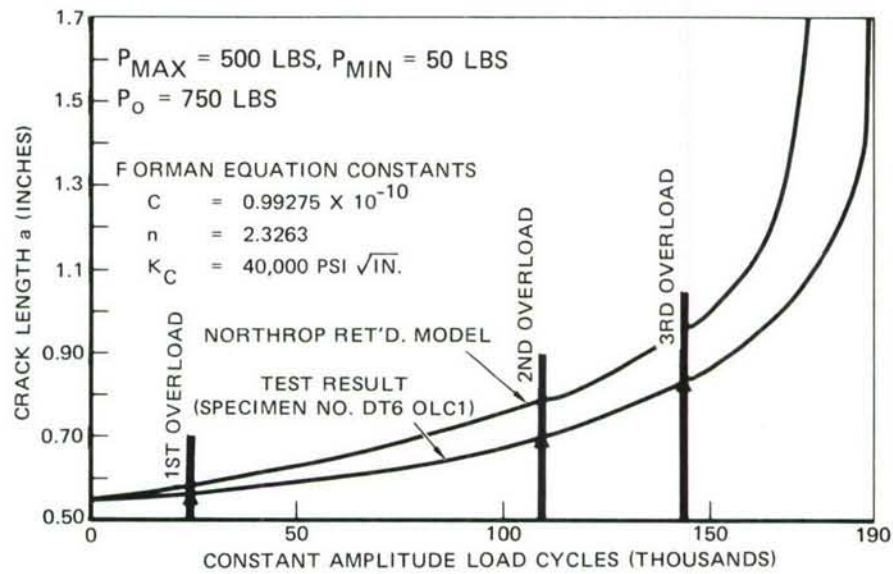
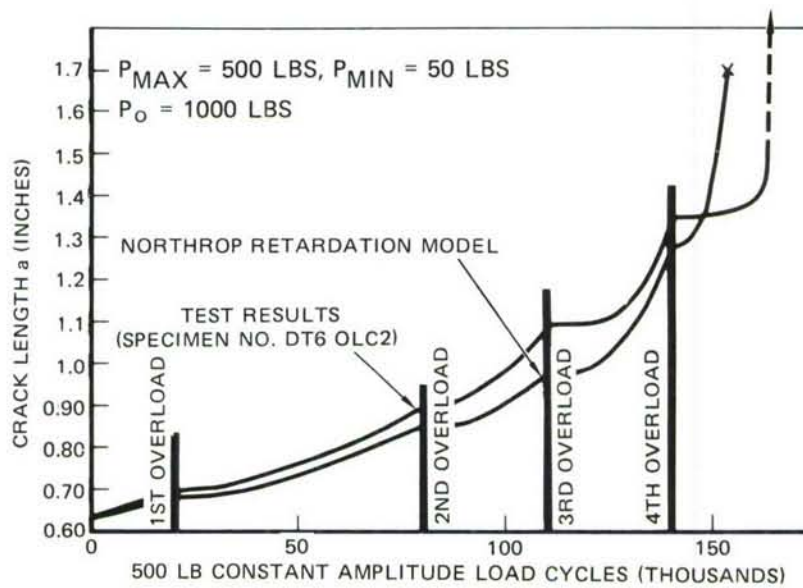
(a) 1.5 OLR

(b) 2.0 OLR

FIGURE 45. COMPARISON OF MEASURED CRACK-GROWTH WITH THAT PREDICTED IN 7075-T6 AT OLR OF 1.5 AND 2.0

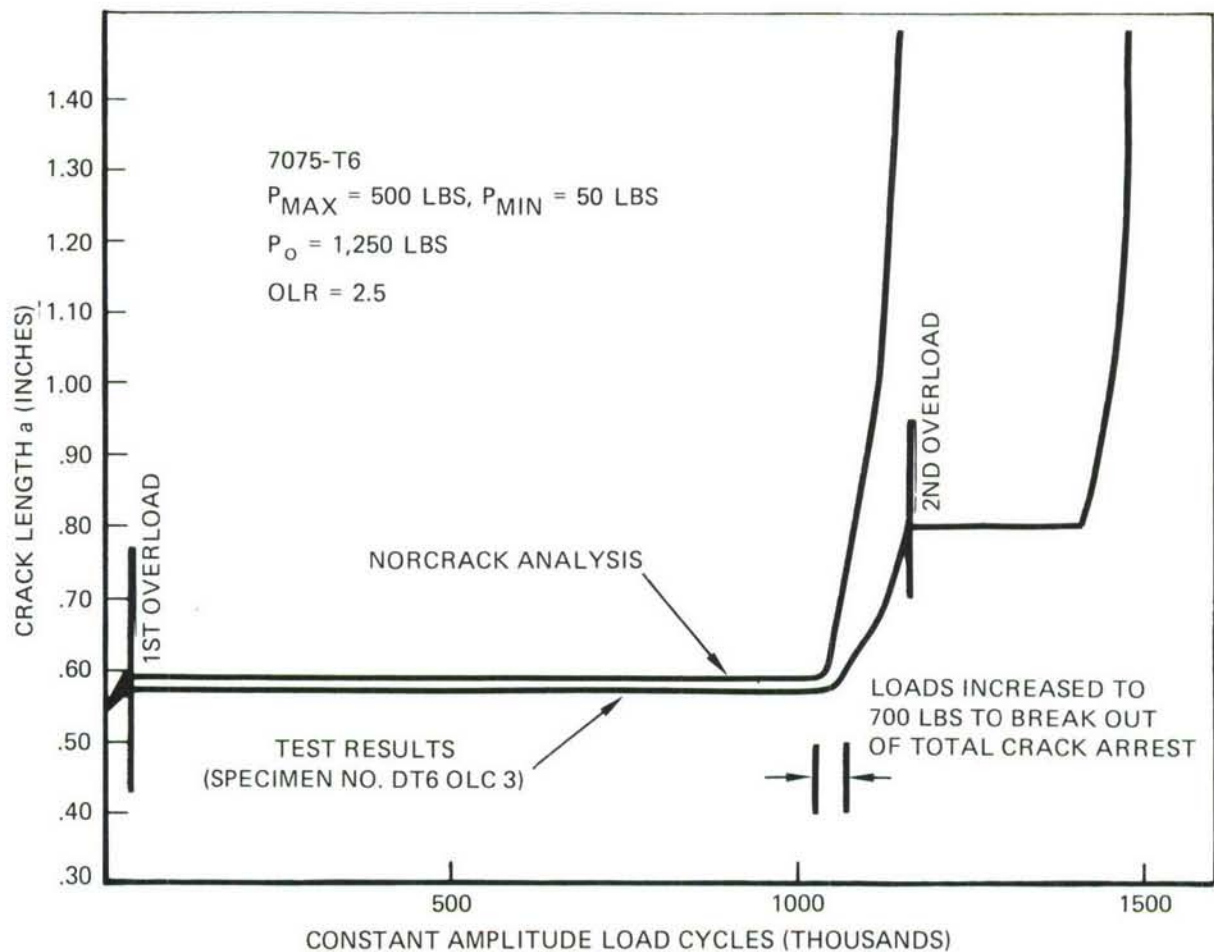
FIGURE 46. COMPARISON OF MEASURED CRACK-GROWTH WITH THAT PREDICTED IN 7075-T6 AT OLR OF 2.5

In these figures, there is reasonable agreement between test and analysis. Figure 46 shows the comparison for an overload ratio of 2.5 where apparent crack arrest was achieved after the first overload. Crack-growth was then achieved by raising the load for a few thousand cycles. In the test, the second overload again caused apparent crack arrest, but eventually crack-growth resumed and the specimen failed. Analytically, this second temporary crack arrest could not be rationally represented.

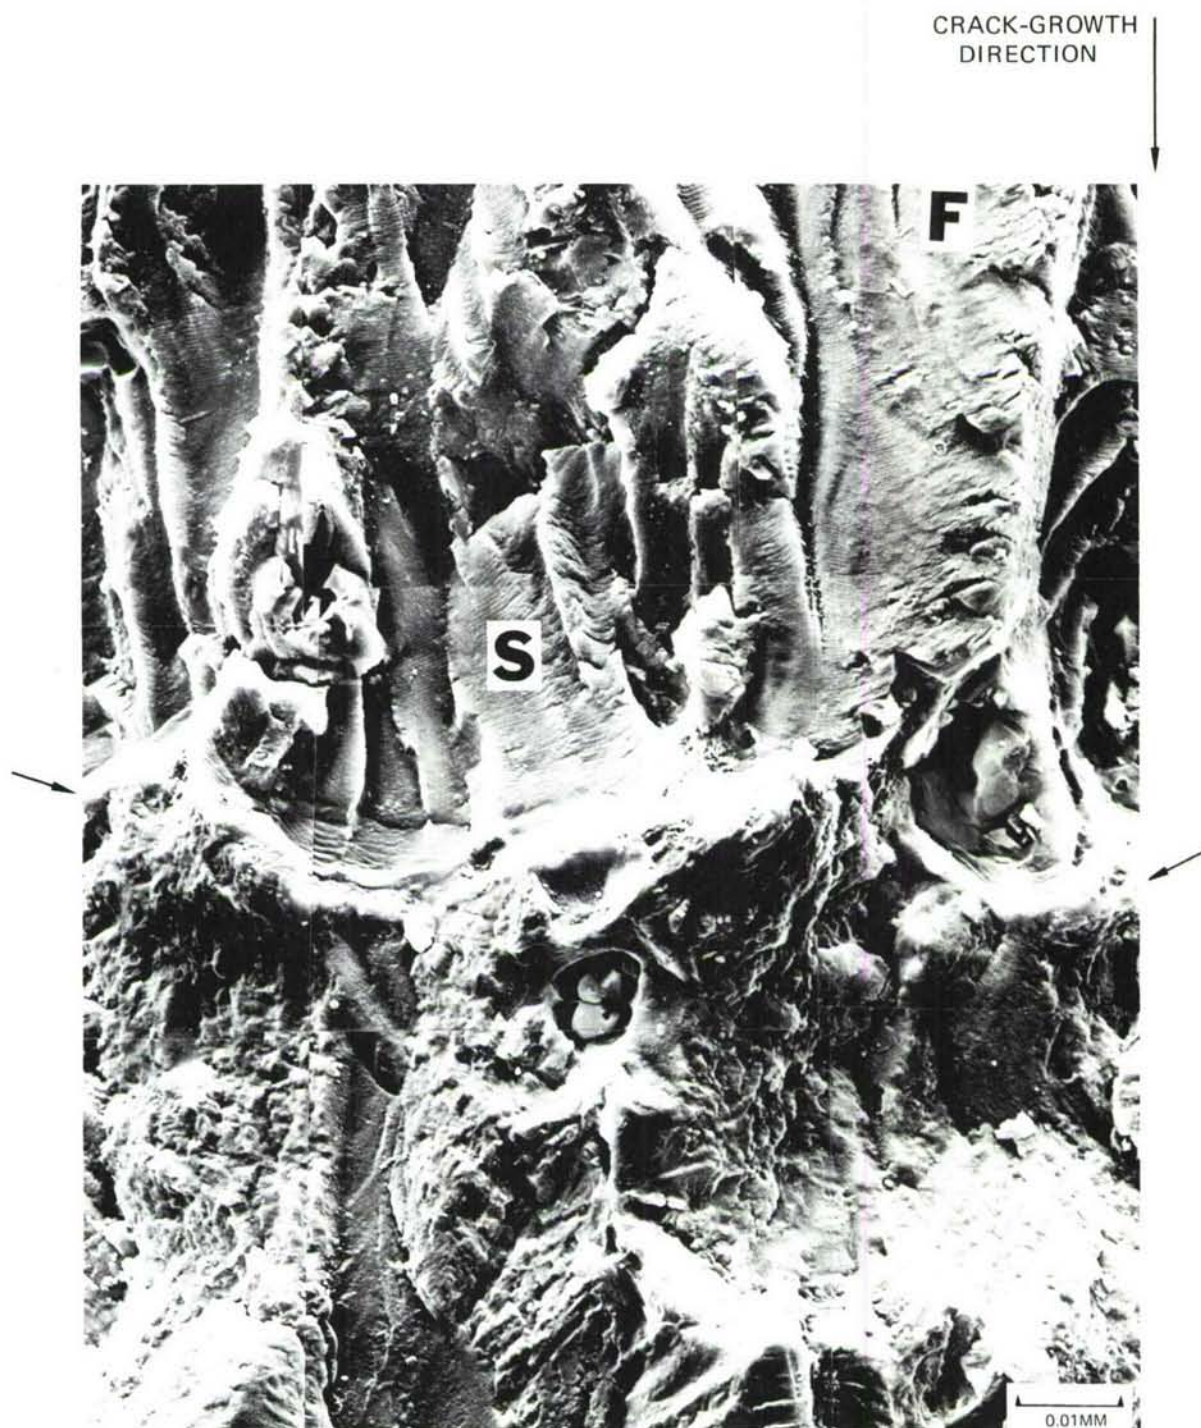
FIGURE 54. A HIGH MAGNIFICATION VIEW OF CENTER REGION OF FIGURE 52 (b)

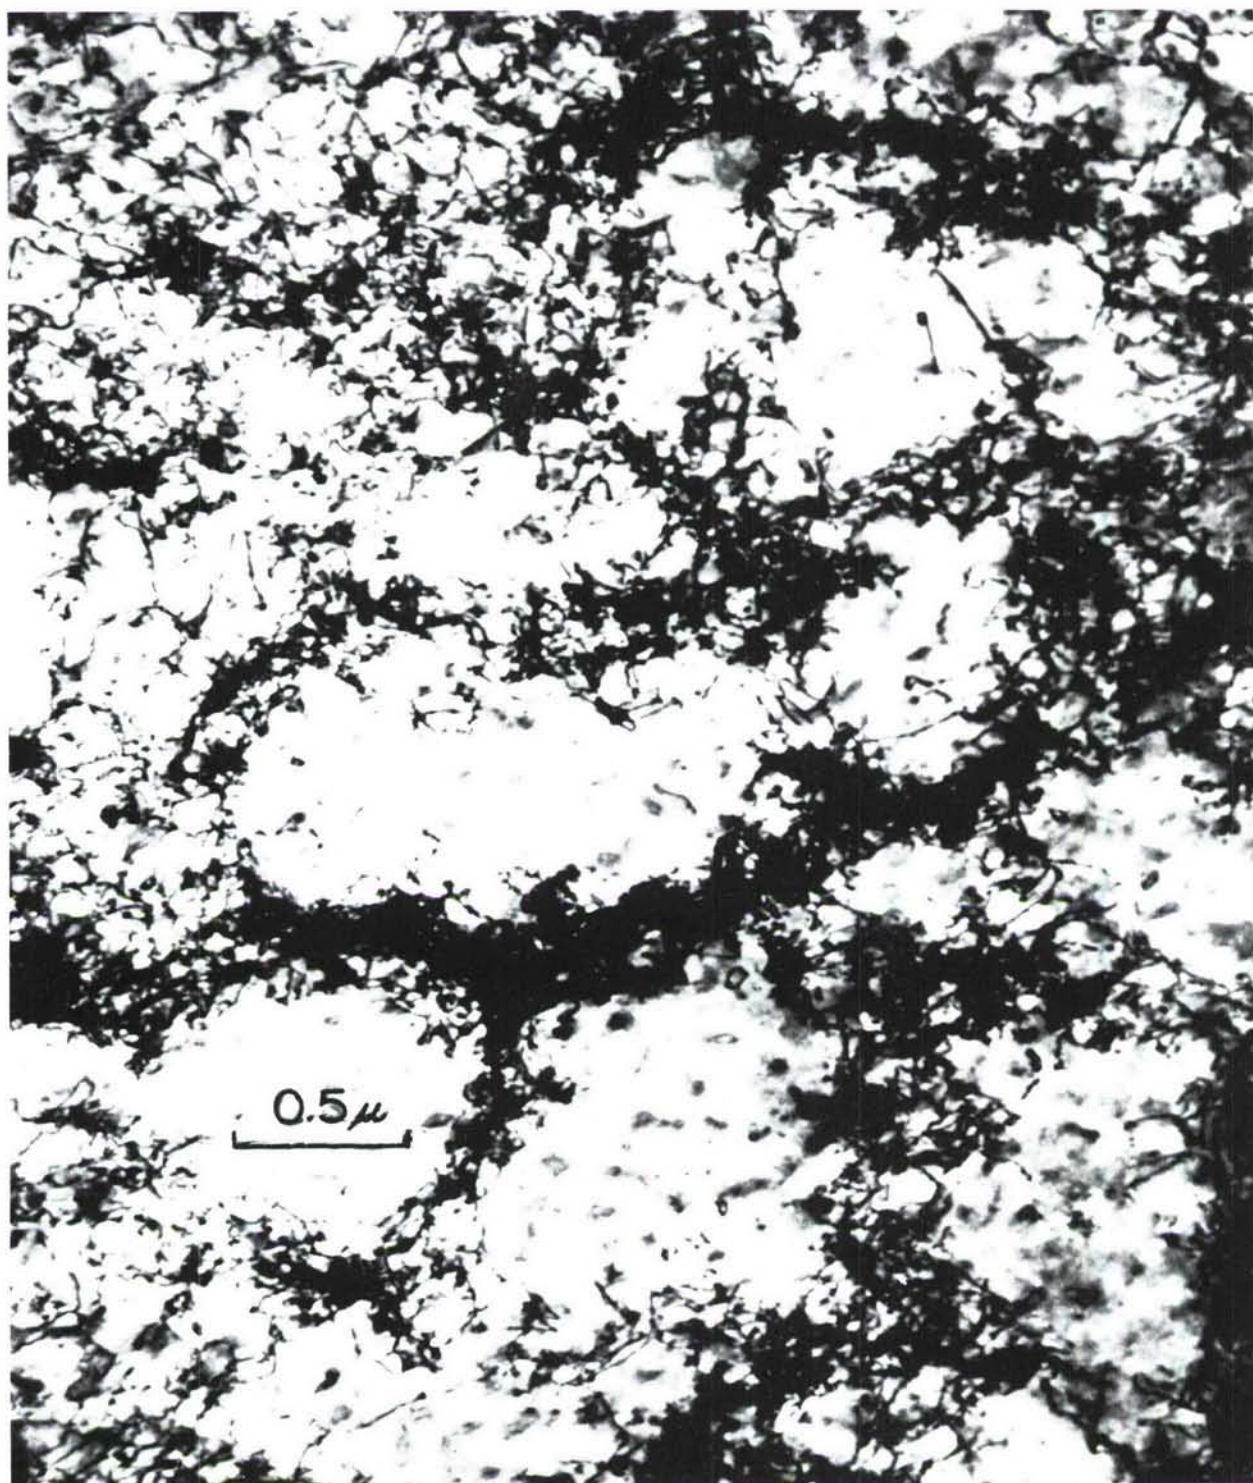
FIGURE 58. DISLOCATION CELL NETWORKS IN THE 100% OVERLOAD REGION OF A 7075-T6 RETARDATION SPECIMEN

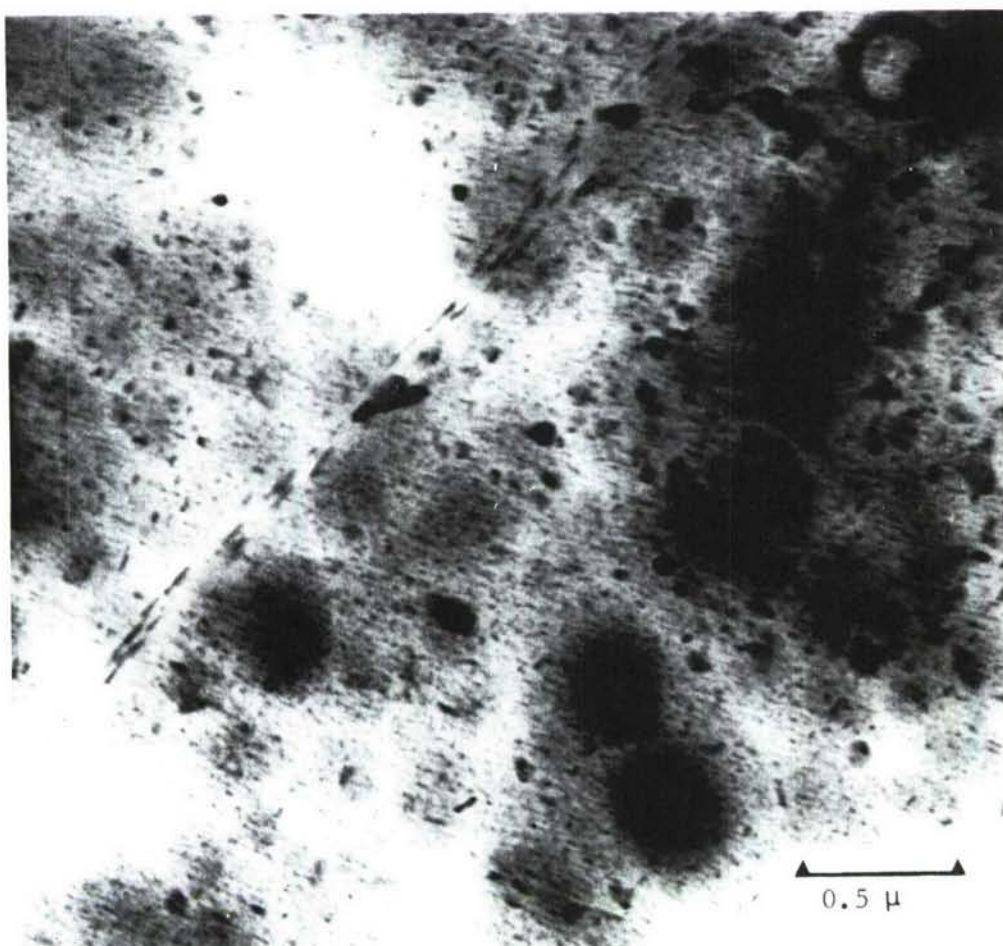
FIGURE 59(a). MICROGRAPH SHOWING EXTENSIVE PRECIPITATION IN A 2024-T3 CRACK-ARREST PLASTIC-ZONE (OLR = 2.5, P_{MAX} = 800 LBS)

In 2024-T8 FIP, an extensive increase in precipitation (platelets of large S') along crystallographic planes giving a "Widmanstatten" type of pattern was observed (Figure 61(a) and (b)). In Figure 61(b), dislocation tangles at an apparent grain boundary can be seen. In HTP of this alloy, areas with dislocation tangles and finer S' network can be seen in Figure 61(c) and (d). The TEM observations in FIP of

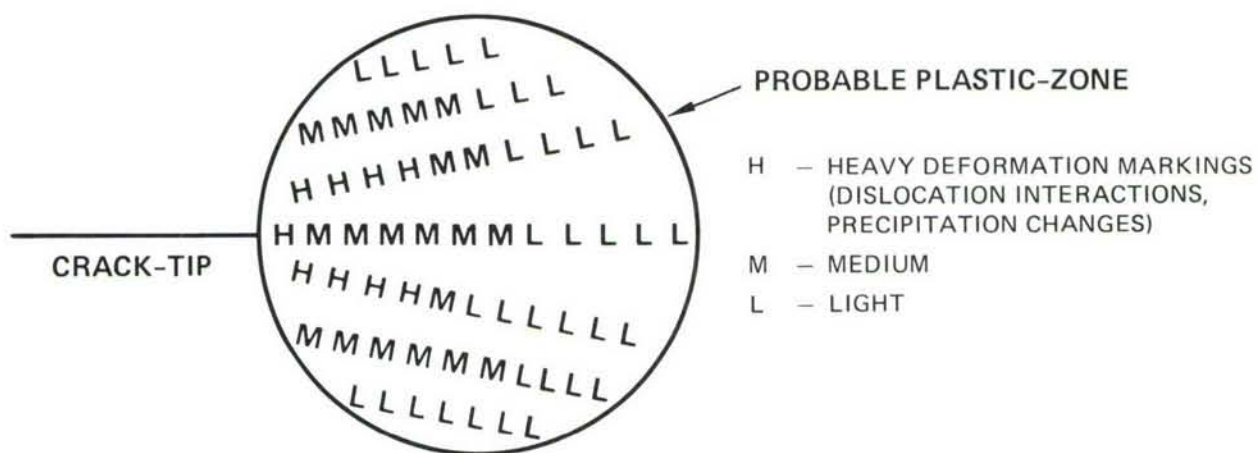
FIGURE 59(b). SCHEMATIC OF CHANGES IN DEFORMATION MARKING OBTAINED BY MAPPING OF 2024-T3 AND 7075-T6 CRACK-ARREST SPECIMENS (OLR = 2.5, P_{MAX} = 800 LBS)

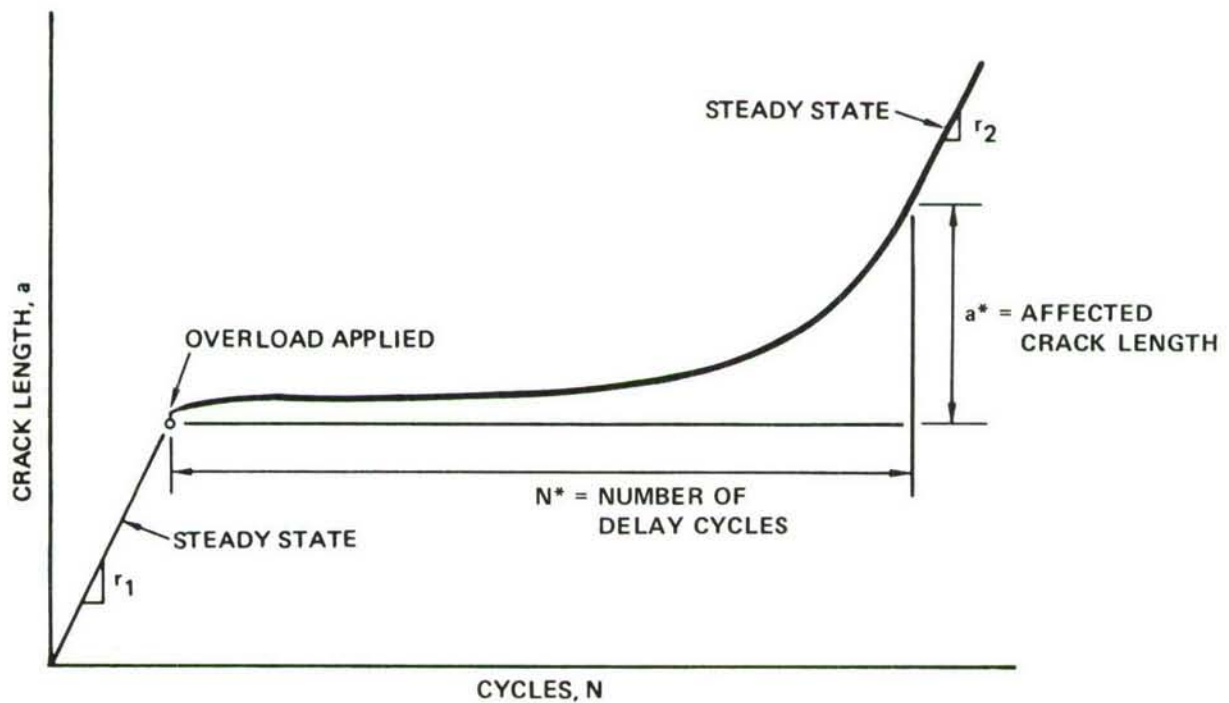
FIGURE A-5. CRACK-GROWTH RATE CURVE RESULTING FROM APPLICATION OF A SINGLE OVERLOAD

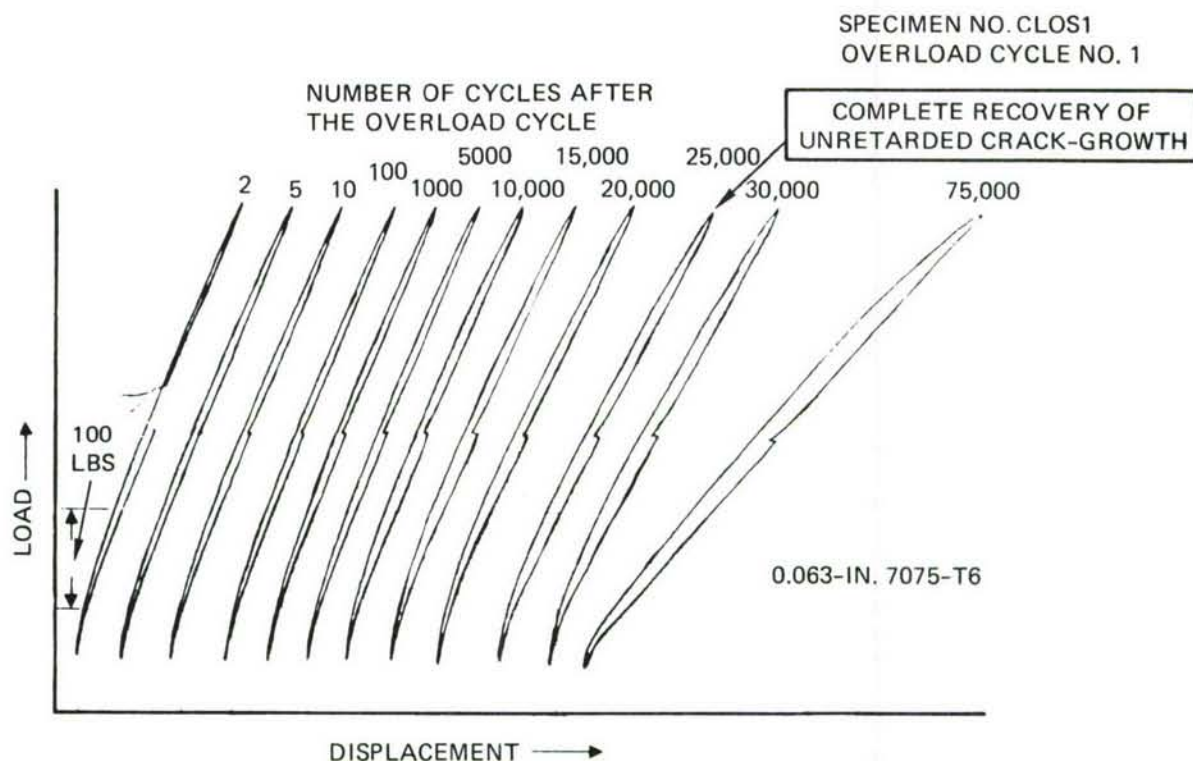
FIGURE A-6. LOAD VS DISPLACEMENT AT INTERVALS DURING FATIGUE TESTING – OVERLOAD RATIO OF 2
